The International Space Station and the Space Debris Environment: 10 years on

Nicholas Johnson¹, Heiner Klinkrad²

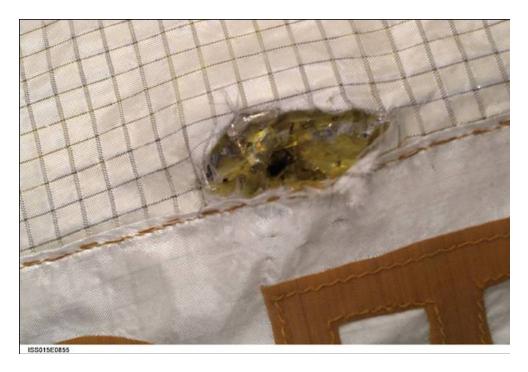
EVA's have revealed several areas of damage due to space debris impacts. One of the most prominent impact sites was found in 2007 on the Zarya module Reference 3). A substantial tear (6.7 cm long and 3.3 cm wide) was discovered in a thermal blanket near the forward end (Figure 7). The nature of the damage suggests an impact from an oblique angle. From laboratory tests at the Hypervelocity Impact Technology Facility of the NASA Johnson Space Center, specialists believe that the impactor probably was 0.2 to 0.3 cm in diameter and penetrated not only the thermal blanket, but also the underlying steel mesh, fiberglass, and aluminum honeycomb layers. Fortunately, the compressor immediately underneath appears to have been untouched.

Figure 7. Tear in thermal blanket of the Zarya module due to space debris impact. Each square of the blanket is \sim 1 cm by 1 cm.
